Dissolution Authority

**TO:** South Meadows Transition Committee  
**FROM:** William P. Beccaro, Committee Chairperson  
**DATE:** October 3, 2024  
**RE:** Notice of Regular Meeting

4. Presentation and Discussion of the following DRAFT Milestone Reports associated with the South Meadows Redevelopment Considerations Study:
  - a. *Abandonment and Removal of Penetrations and Encroachments* of the flood control system (*Attachment 2*)

- b. *Floodwall Penetration Operation, Maintenance, and Inspection Plan* (*Attachment 3*)
  - c. *Floodwall Penetration Emergency Preparedness Plan* (*Attachment 4*)

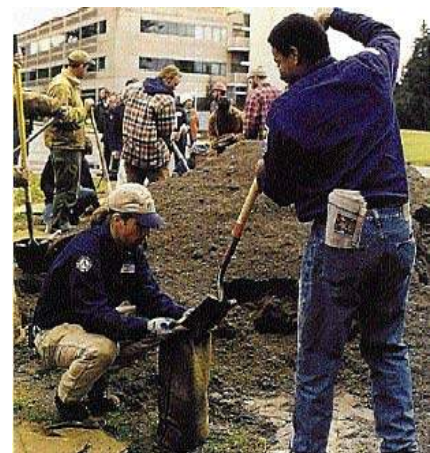
*Figure D.1 This two-person team is positioned properly for sandbag filling.*

Filling sandbags manually requires two people. One member of the team folds the throat of the bag outward to form a collar, and holds it open so that the other person can shovel in material. The one holding the bag should hold it between or slightly in front of his or her feet, either crouching with his elbows resting on his knees or standing with his knees slightly flexed, while keeping his head and face as far away from the shovel as possible. Both people should be wearing gloves to protect their hands, and safety goggles may also be desirable, especially on dry or windy days.

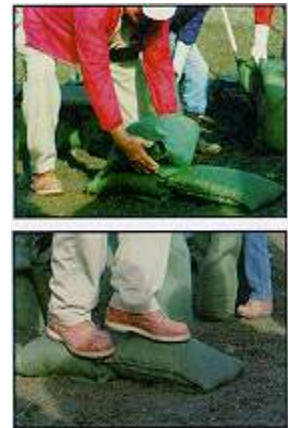
*Place each succeeding bag tightly against and partially overlapping the previous one. Compact and shape each bag by walking on it.*

*Figure D.3 Sandbag placement – compacting bags together.*

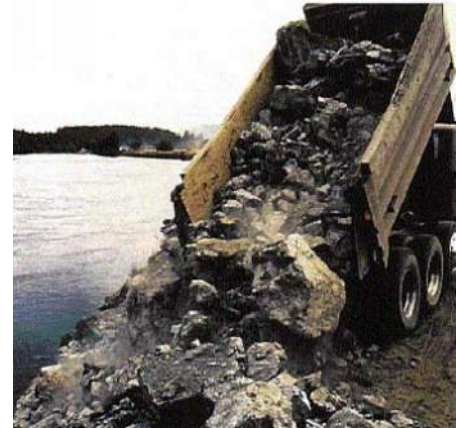
**Figure D.10** *Placement of Riprap. Careful use of an excavator may allow for more accurate placement than is shown above.*

If scour begins to take place after water is up on the levee, a protective berm should be constructed over the entire scour area using stone, slag, or other durable material with sufficient size and weight withstand the erosive velocity of the current. Construction of this berm will generally require equipment capable of operating from the levee crown. Riprap has been used to provide slope protection where erosive forces were too large to be effectively controlled by other means. Objections to using riprap when flood fighting include the cost and the large quantities that are typically necessary to protect a given area. It's usually very difficult to control the placement of the riprap, particularly during times of high water, but careful use of an excavator has been effective even in difficult conditions.
